EcoSeal, LLC

Bio Seal 911 and ES 600 Concrete Tank Repair and Coating

Rio Services Texas and Galveston County Texas City Dike

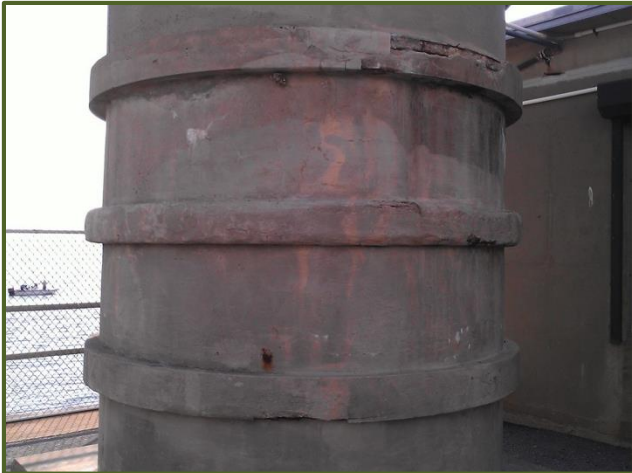
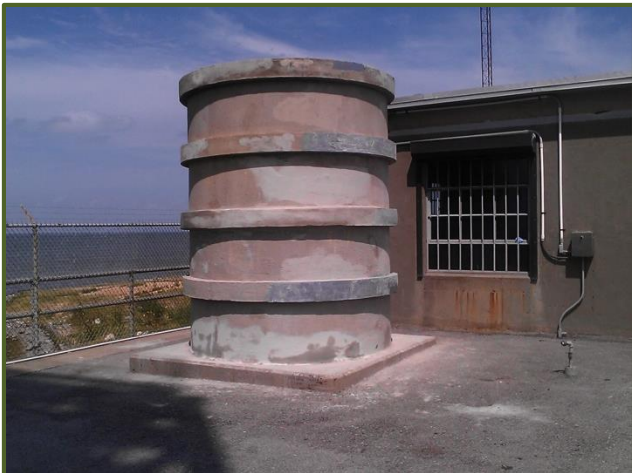
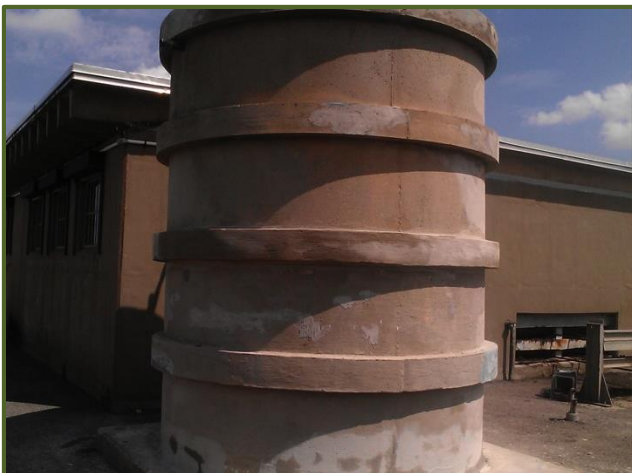
Galveston County has a water tank designed to hold water for pressure service, and the tank was in bad need of repair. The concrete was Spalding, and had cracks inside and out. Our team was hired to repair the tank and coat inside and out to increase the service life.

Bio Fix 911 was used to fill and shape the cracks, and missing concrete areas. Fast cure, and ease of troweling makes this a great product for this service.

ES 600 is designed for total Immersion service, and was used to fight back the water intrusion from the saturated concrete. Both sides were coated to assure a strong seal, and stop future rusting, and Spalding issues,
