## **Norwegian Sea Cruise Ship Case Study- Ship Decking**

*Fast curing, eco-friendly, one-coat anti-corrosion membrane that repels the salt-water environment.*

Norwegian Sea Cruise Ship  
Upper Deck Corrosion Prevention  
Florida Gulf Coast  
2000

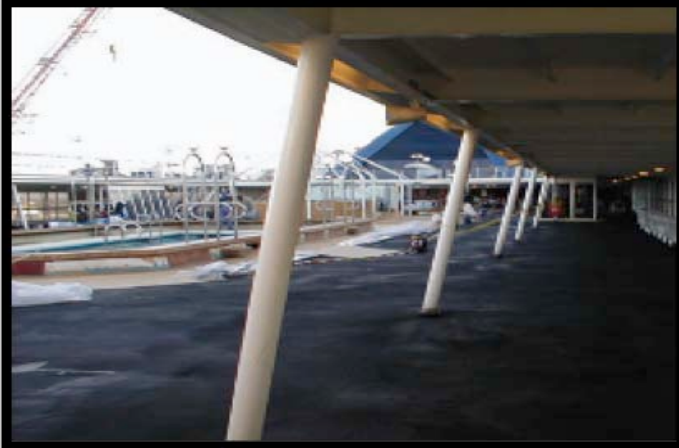
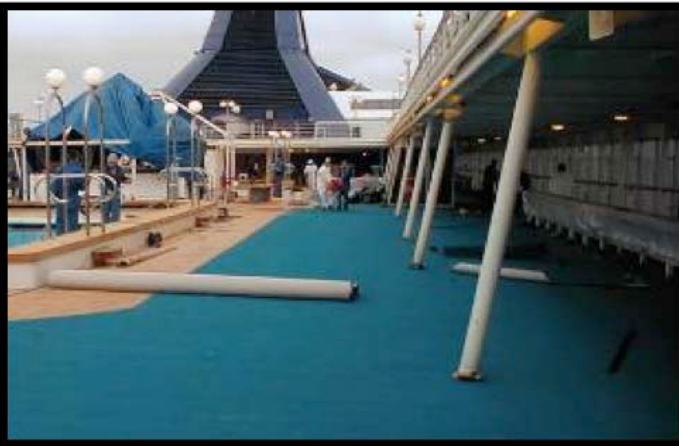
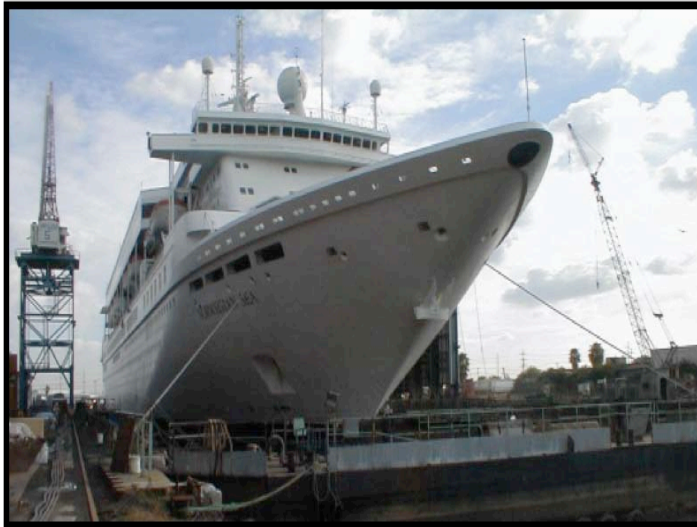
In 2000, Norwegian Cruise Lines contracted with Rhino to repair and protect the upper decks of one of their cruise ships, which had started to corrode badly due to the salt air as well as the swimming pool situated mid-deck. The upper deck covering had to be removed and the underlying deck sprayed with ES 300. A new decorative matting deck cover was installed over the ES 300. This entire project was done while the ship was relocated from Houston to Florida by the ship's own staff, supervised by Rhino. To date, the deck has shown no further signs of corrosion.

**Corrosion Prevention:** The ES 300 Corrosion Prevention System was installed directly onto the upper deck of the cruise ship and then covered with a decorative deck material. ES 300's elastomeric properties, tenacious adhesion, and ability to provide a complete corrosion and moisture barrier for a substrate impacted by the salt-water environment made it ideal for this application.

**Ease of Installation:** The installation had to be done by staff labor, and it had to be completed in route from Texas to Florida, prior to taking on passengers. The single coat spray application enabled the crew to accomplish this in 4 days, under EcoSeal's supervision.
