## ***River Oaks Residential Bldg. Case Study - Waterproofing***

River Oaks Luxury Apartments  
Planter Boxes over Parking Garage  
Houston, TX  
1997

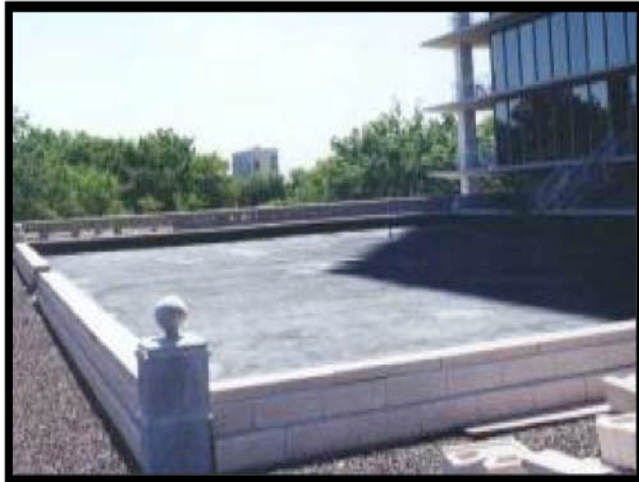
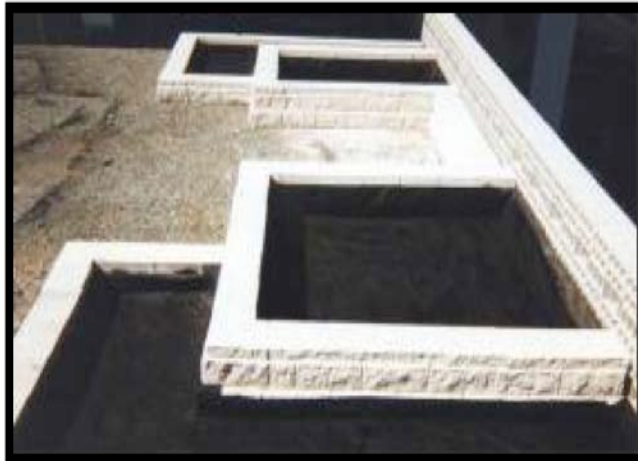
*Waterproofing membrane protects substrates from moisture intrusion and water damage.*

In 1997, The River Oaks Luxury Apartments were having issues with their roof planter boxes leaking into the parking garage below. The existing soil and landscape were removed from the boxes and a geotextile fabric was laid down so that an even surface and corresponding uniform installation could be successfully completed. The ES 200 Waterproofing membrane was installed onto the geotextile sheeting and then the soil and landscape were reinstalled on top of the new barrier membrane. The ES 200 provided a simple, cost effective solution for the building and their residents. This system remains in place today with no reports of further leaks.

**Roofing/Waterproofing:** The ES 200 Waterproofing System was utilized to eliminate the continuing problems associated with the leaking planter boxes. ES 200's physical properties were ideal to create a permanent liner system in the boxes and protect the building's substrate and infrastructure from future water intrusion. The fact that the membrane forms instantly upon contact with the substrate, following all contours, is touch-dry in minutes and achieves complete chemical cure in 24 to 48 hours was another critical benefit from this system, as it allowed the boxes to be placed back in service within hours of installation.
